A Dramatic New Approach To The C-130/L100 Wing Flap Actuators

- Improve Service Life
- Maintain Interchangability at the Gearbox Level
- Reduce Cost

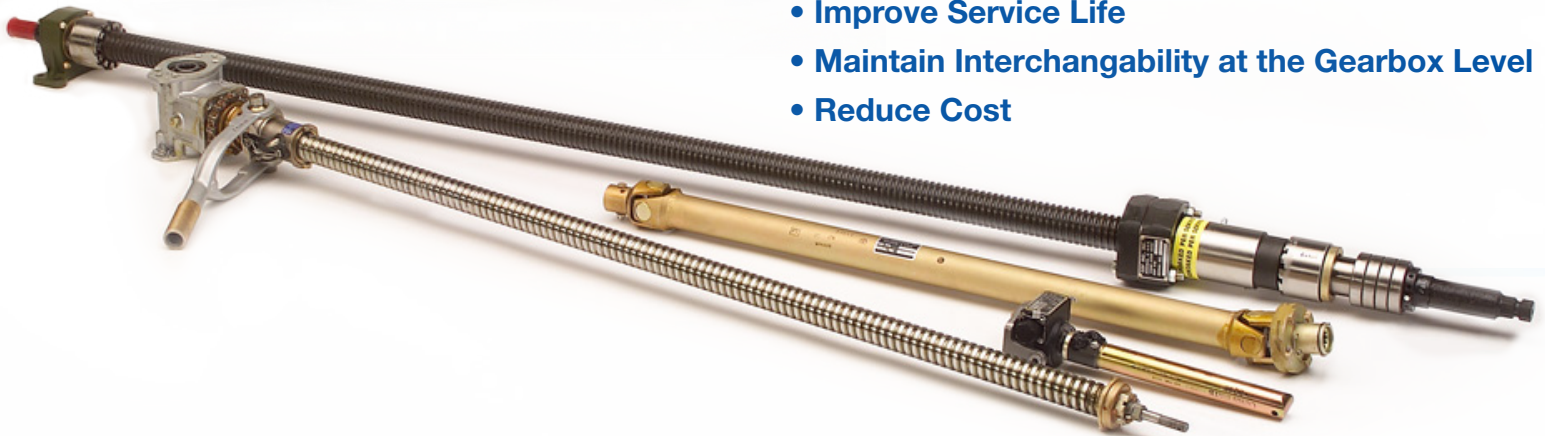
- **STAINLESS STEEL Precision Thread Rolled Ball Screw**
- **STAINLESS STEEL Torsion Bar with Twice the Length or Engagement**
- **Heat Treated Electroless Nickel Plated Ball Nut**
- **STAINLESS STEEL Recirculating Balls**
- **STAINLESS STEEL Output Shaft Coupling**
- **Heavy Duty Wipers**
